3.2 Operations and Maintenance

3.2.1 Feed Plant Operations

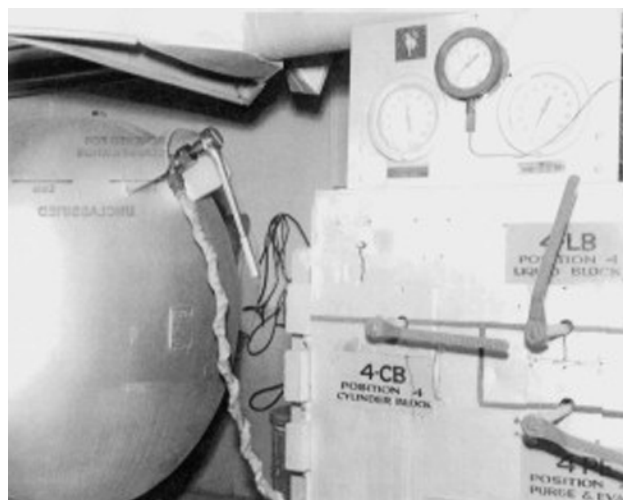
Cylinder Filling Operation

During the 1950s, UF_6 gas was pressurized for feeding to the cascade by heating the cylinders in warm water baths; the water baths had minimal engineered

safety features. In November 1960, a cylinder was valved into the cascade before the water bath was fully heated, resulting in backflow into the cylinder from the cascade and an overfill condition. When the inappropriate valving was discovered, the cylinder isolation valve was closed. As the water bath continued to heat the cylinder, the cylinder overpressurized, rupturing the cylinder and releasing approximately 6,800 pounds of uranium.

In the early 1960s, the water baths were replaced with autoclaves, principally located in Buildings C-333A and C-337A, with each building containing several autoclave feed stations. Each autoclave served as a containment boundary in case a leak developed and was equipped with appropriate alarms, indicators, valves, and a remote cylinder valve closure device. Prior to connection to the cascade, each UF_6 cylinder was inspected for damage and confirmed to be safe for use. If a cylinder was found to be defective, it was tagged and moved aside for special handling. Following inspection, a heat traced copper pipe (pigtail) was attached to the cylinder valve and to a corresponding connection within the autoclave, the cylinder valve was opened, the autoclave was closed, and the various alarms were tested. Once the connection integrity and feed path clearance were confirmed, steam heat was initiated to vaporize the UF_6 and began feeding it to its corresponding assay point in the cascade. A UF_6 release within an autoclave would actuate an automatic emergency shutdown and autoclave isolation to protect workers and the environment.

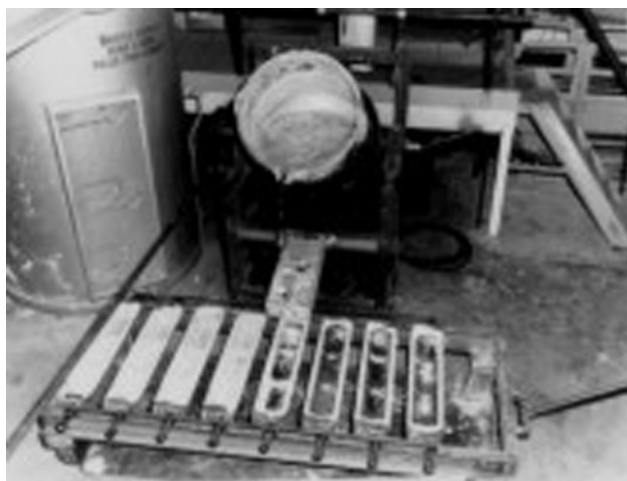
Aluminum Pouring Operations

Three smelters operated in C-746A, including a nickel induction furnace, a reverberatory furnace used to melt clean aluminum, and an aluminum sweating furnace. Little data on smelter operations at the Plant was available to the investigation team because records were stored in contaminated waste drums or were removed by another DOE team investigating scrap metal recovery at the Plant. A 1972 study of radionuclides in scrap indicated the potential for airborne concentrations of uranium during loading of melting pots; however, no uranium fumes were detected during alloy melting or pouring.

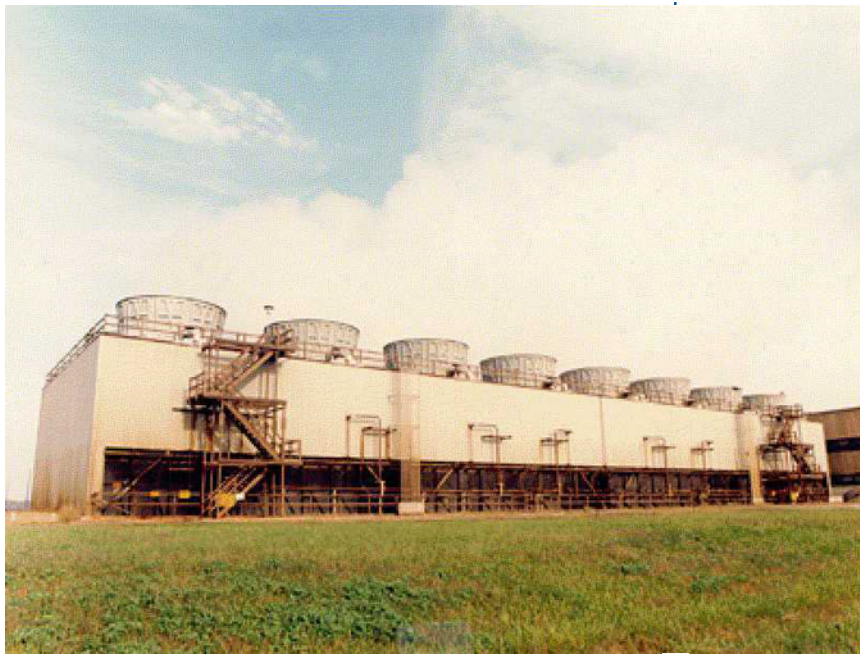
Cooling Towers

The cooling towers were treated annually with fungicides, principally to protect wooden components from fungal attack and deterioration. Inspections in 1958 showed significant internal fungal attack. Several different chemical treatments were tested, some of which involved arsenic and chromate compounds. Additionally, much of the original redwood was replaced with pressure treated lumber. Finally, the commercially available wood preservative/fungicide pentachlorophenol (PCP) was selected.

As originally practiced, fungicide spraying involved operators climbing within the cooling tower structure with ladders, work platforms, safety ropes and guidelines, and finding perches on cooling tower structural members to stand on while directing the spray. The workers wore protective clothing and breathing apparatus. This difficult task was made more hazardous by the risk of slipping and falling. At least one worker fell within the confines of the cooling tower during repair operations. In the early 1980s, a modified in-place fungicide treatment process was developed that did not require any climbing within the cooling tower, thereby significantly improving safety and reducing the difficulty of the job.
